## How The 2015 Sydney Cyclone Eroded Our Shores

### The April 2015 East Coast Cyclone

*by Prof. Andrew Short*

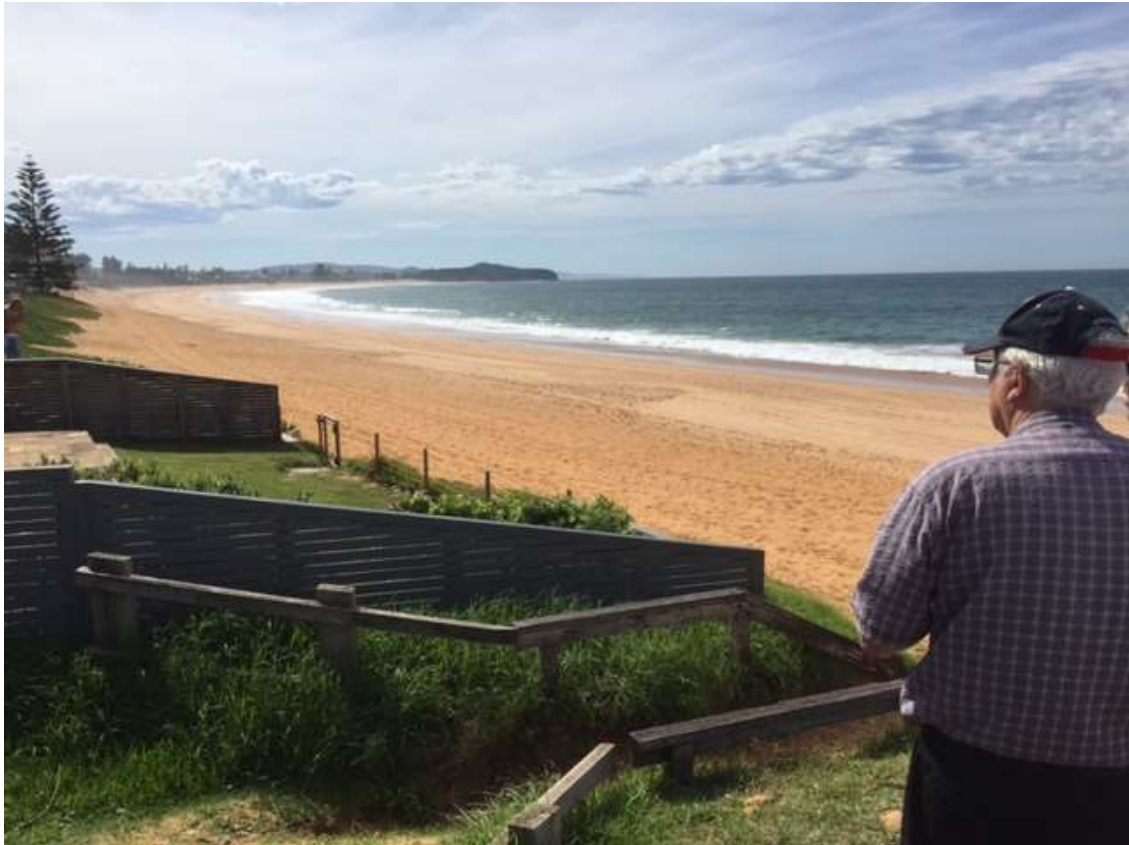
Figure 4. Collaroy Beach on 16 April 2015, as wide as it gets (Photo: A D Short).

On the seaward side of the beach the waves were ripping the beaches apart and carrying huge volumes of sand seaward in massive rips systems to be deposited as offshore bars and beyond. Narrabeen beach, which had been unusually wide a week before, retreated at much as 30 m exposing old seawalls in places (Figures 4 & 5).

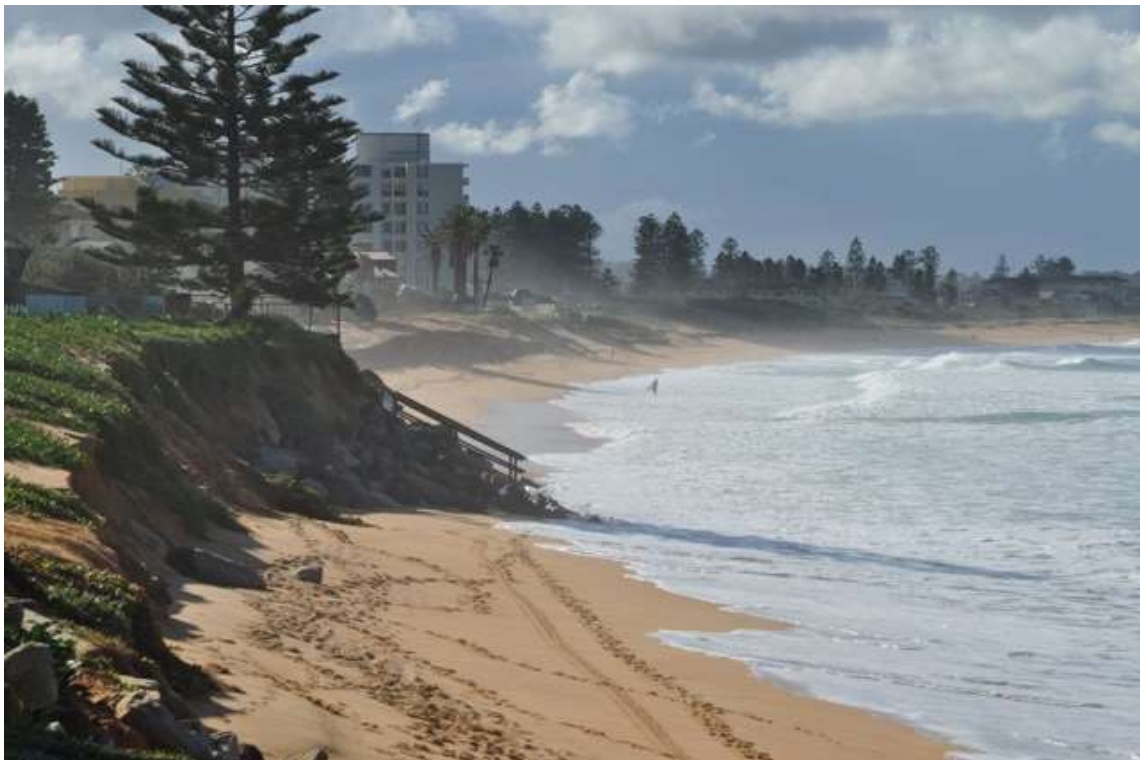
Figure 5. Collaroy Beach a week later on 23 April 2015, following 25-30 m of shoreline retreat (same pine tree as in Figure 4) (Photo: A Gordon).

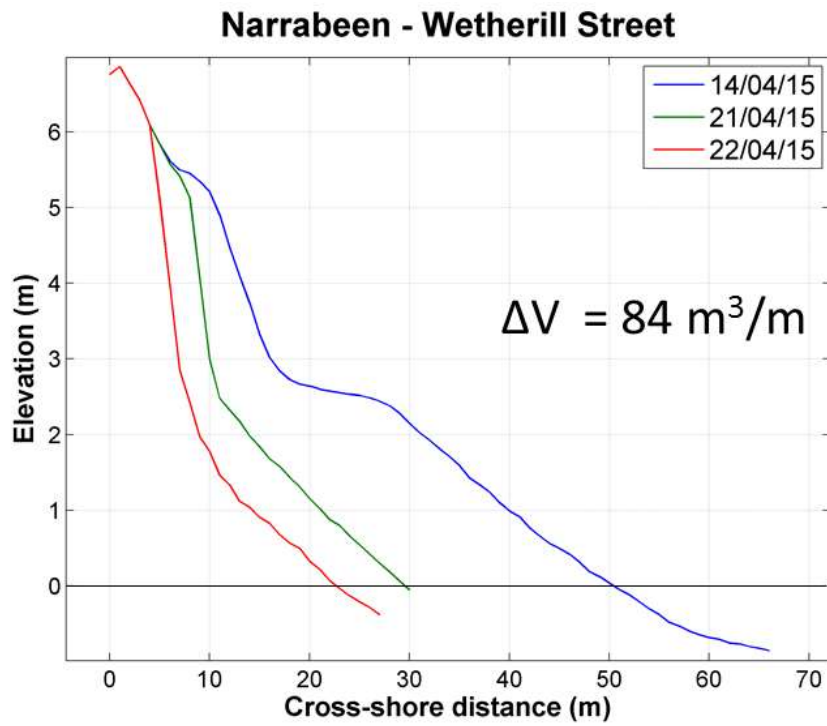
Figure 6. A cross-section of Collaroy beach (same area as Figure 5) before and after the storm. Source: Water Research Laboratory, School of Civil and Environmental Engineering, UNSW.

Figure 6 shows how the shoreline at Wetherill St, Collaroy eroded 25 m with 84 m<sup>3</sup> of sand eroded from every metre of beach, bringing to total amount of sand eroded from the entire Narrabeen-Collaroy to about 250 000 m<sup>3</sup>. This amount of erosion is similar in scale to that caused by the 2007 'Pasha Bulka' storm.
